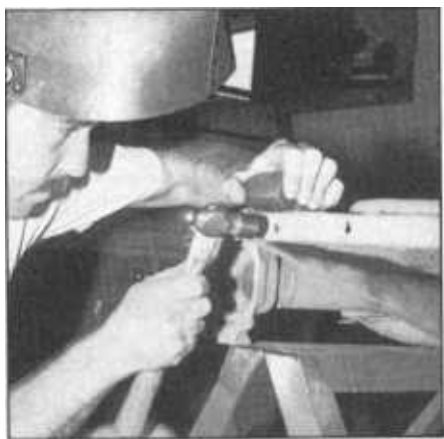
ABOVE LEFT, to remove some of the zillions of dents usually found on a floor pan, Tim Orchard used a hammer and dolly. **BELOW**, a wire wheel attachment helped remove weld caulking.

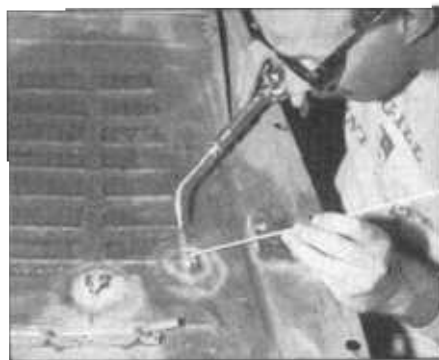
ABOVE, even with sandblasting, the factory weld caulking remained and had to be removed using a torch and putty knife. **LEFT**, during the high-pressure sandblasting, a few small holes were created and we filled them back up with low-heat braze welding.
