Do your feet get soaked every time it rains? Do your Nike's need a retread from dragging on the pavement? Are you tired of asking your passengers to please keep their feet inside the car? The problem is obvious — the floor pan of your prized VW is rusted clean through.

But a rusted floor doesn't have to mean the early retirement of your VW. There is a repair that will literally make your car's pan as good as new.

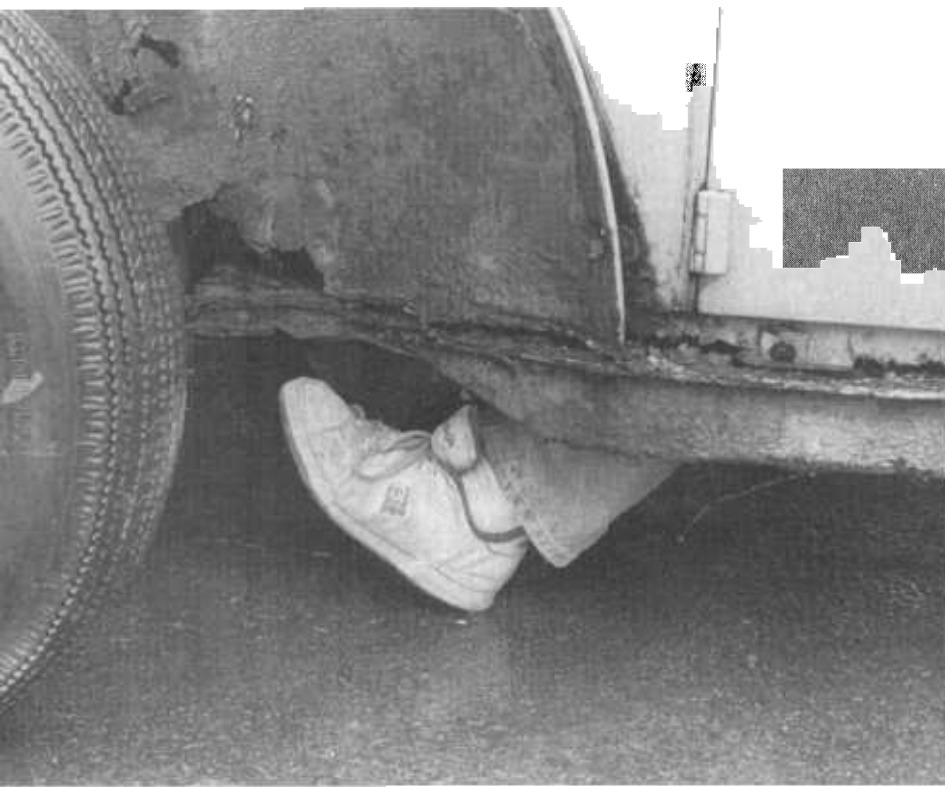
RIGHT, rusted out pans are a common VW problem. With the seat and carpeting removed, it's obvious just how bad the problem was on this Bug!

The first step of the repair is to remove the seats and carpeting from the inside of the car. This will give you a good view of just how extensive the rust damage is. Next, inspect the bottom of the car, and remove any obstructions. If you are repairing the right side, temporarily relocate the gas evaporator hose that is clipped to the floor pan bolts. You don't want venting gasoline fumes in the area when welding or grinding for obvious reasons.

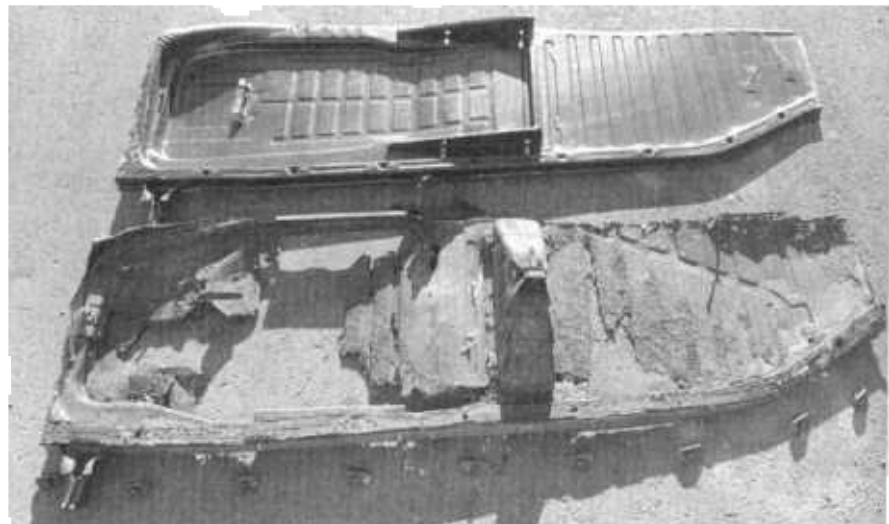
Replacement floor panels are available only for '70 and earlier Beetles, but these can be made to work on later cars with minor modifications. Notice the seat rails welded to the replacement panel — you will need to remove these for later cars.

The only floor pan replacement panels currently available are designed to fit '70 and earlier Bugs. These can easily be modified, however, to fit later cars. The main difference is in the way the front

seats attach. The seat tracks on '70 and earlier cars are attached right to the floor and the replacement panel comes with tracks welded in place. On '71 and '72 cars, you simply replace the seat tracks. On '73 and later cars, like the one in our sample repair, you must remove the tracks on the replacement panel, then mount the

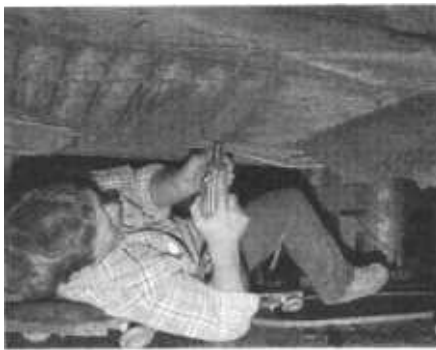
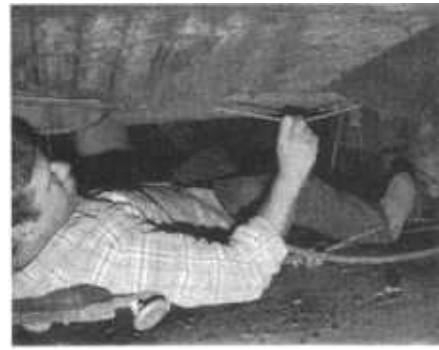
ABOVE LEFT, the first step of our repair required removing the nine body bolts along the outer edge of the floor pan that secure the floor to the body. **RIGHT**, if you are working on the right side of the car, it is wise to carefully relocate the gas tank evaporator hose. Welding, grinding and gasoline fumes are not a good combination.

Next, remove the floor pan bolts, nine per side, that hold the floor section to the pan. Pry the pan down from the heater channel being very careful not to damage the floor pan gasket sandwiched between the two. Break the inside tunnel, front and rear edges of the floor loose with an air chisel. This can be done with a hammer and chisel, carefully breaking

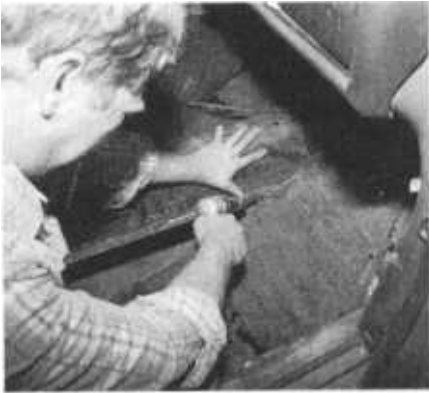
ABOVE, after removing the seats and carpeting, the interior floor pan will be exposed. Pry the outer edge of the pan down from the heater channel, taking care not to damage the pan gasket. Then use an air chisel to break the welds along the tunnel, and front and rear of the floor.

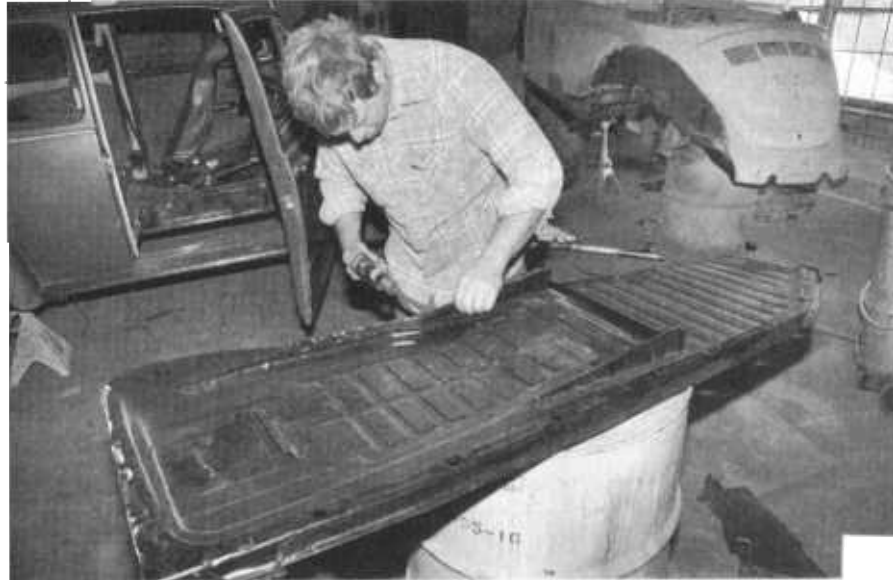
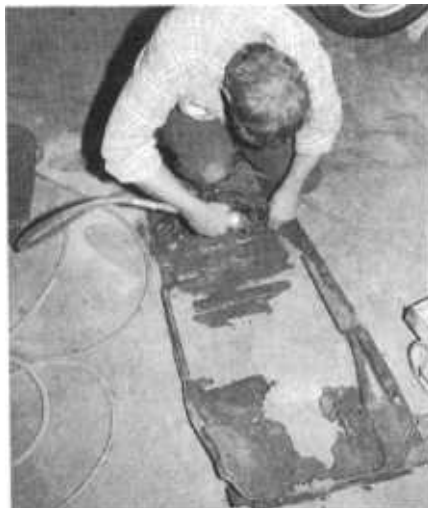
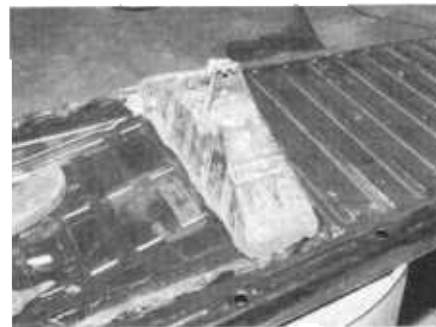
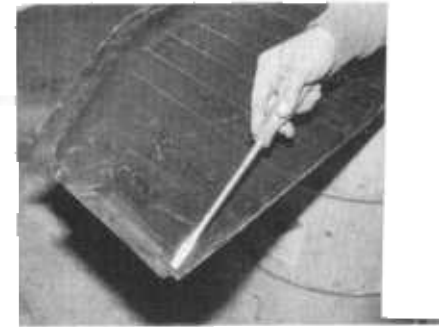
TOP, if using the later seats, remove the rails from the new pan with an air chisel. **RIGHT**, now carefully remove the seat pedestal from the old floor. **ABOVE LEFT**, check pedestal fit by placing on the new pan, and trim as necessary to fit — don't weld in place until the pan is in the car. **RIGHT**, check the new panel for fit, it may be necessary to trim and notch the front edge to clear a factory weld.

seat pedestal from the old pan on the new floor. The seat slide tracks mount to the tunnel on the inside and the inner heater channel rail on the outside. If these need to be replaced, they are still available from VW. Convertibles are the same except for the jack support that is integrated into the floor pan, requiring extra work.

Once the old floor section is dropped out of the car, it is time to prepare the replacement section. There is not much to do on '70 and earlier cars, but later cars will need modifications for the seat mounts. Our sample car was a later model, so the seat pedestal was removed from the old floor. The seat rails were then removed from the replacement panel to accept the later model mounts. The front edge of the replacement floor will likely need to be trimmed and notched to fit the pan.

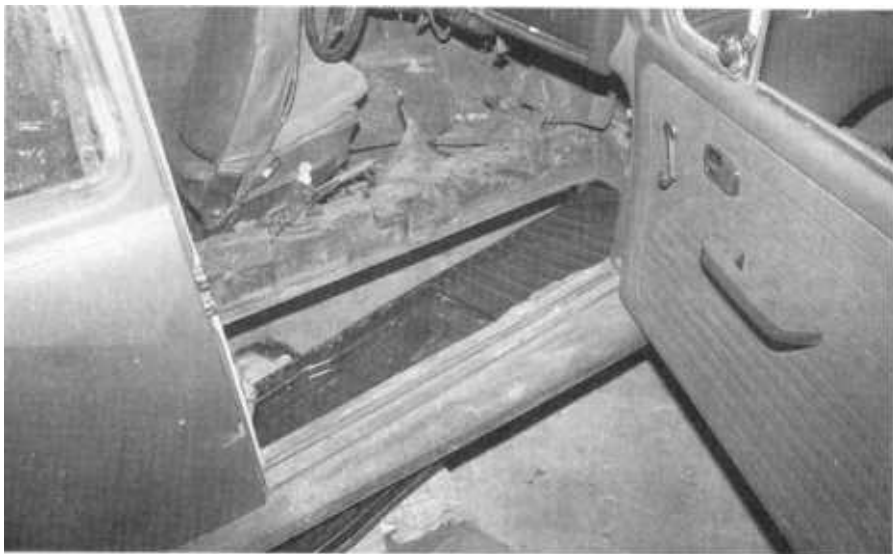
ABOVE, clean and grind off all old welds along the bottom edge of the tunnel where you will be welding to ensure a proper fit. Position the new floor back in the opening after mounting the original pan gasket.

Next, clean the surface along the tunnel and front and rear of the pan to be welded. Knock any old spot welds down with a grinder so that you have a flush surface to mate the new panel to. Mount the original floor pan gasket to the new floor. Position the replacement panel to the car, checking for a proper fit.

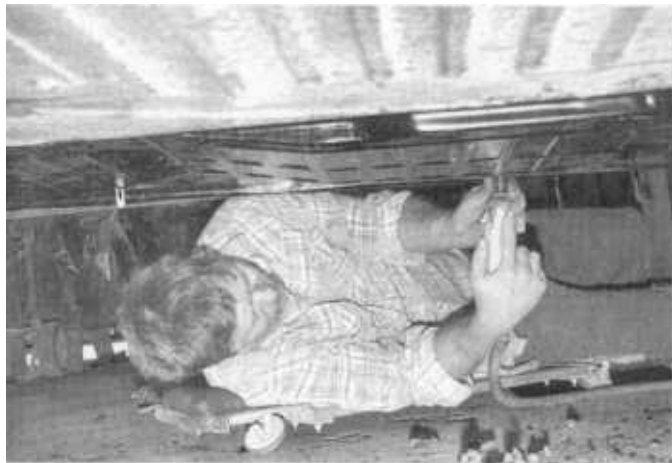
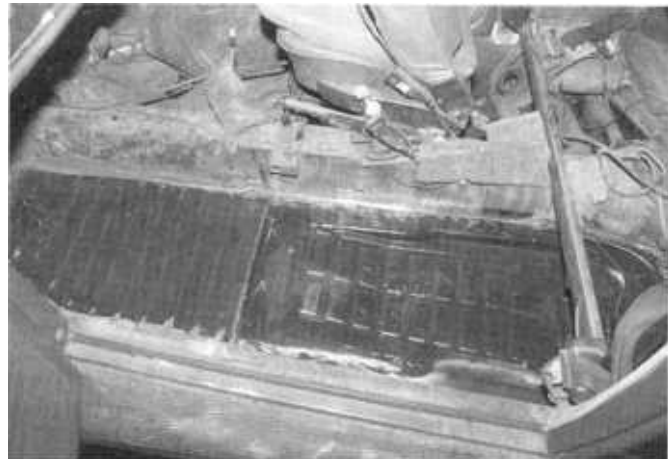
ABOVE LEFT, reinstall the nine bolts then secure the floor to the outer portion of the car making sure the gasket is aligned. **ABOVE RIGHT**, press the two pieces together on the tunnel-side edge of the floor and tack weld in position. Use a body hammer to knock down any high spots. This is how the section will look once installed.

bolts along the outside edge. Press the inside (tunnel) edge together tightly and tack weld in place. If there are any high spots, use a body hammer to fine tune the fit. Weld the tunnel side in, Paul recommends using beads approximately 1-½ inches long and 4-inches apart. Jump from one part of the panel to another to keep from concentrating the heat in one area. If you just lay a nice long bead down the seam, the panel is very likely to warp from the excessive heat. Weld the front and rear of the panel in place. Using a bare seat frame as a jig, you can weld the seat pedestal in and replace the side seat rails if necessary.

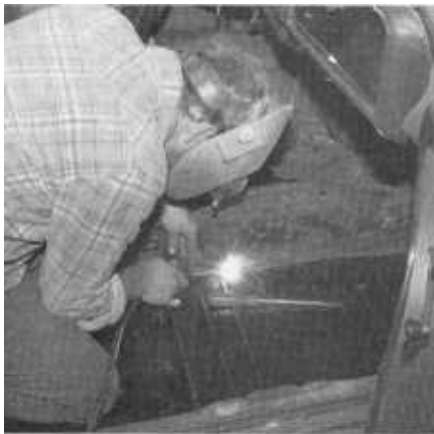
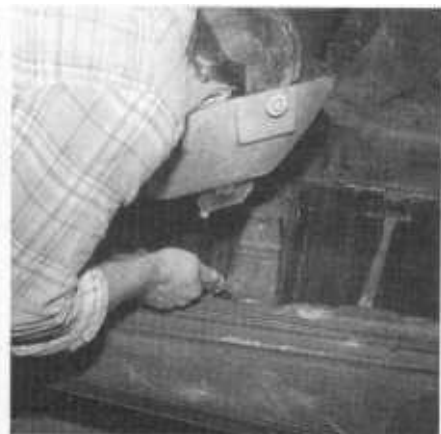
ABOVE LEFT, complete the welding by laying short beads, approximately 1.5-in. long and four inches apart, along tunnel-side of the floor. To prevent warpage, jump around and keep heat buildup to a minimum. Weld front and rear in place using the same method. **ABOVE RIGHT**, now weld old seat pedestal in place on the new floor panel.

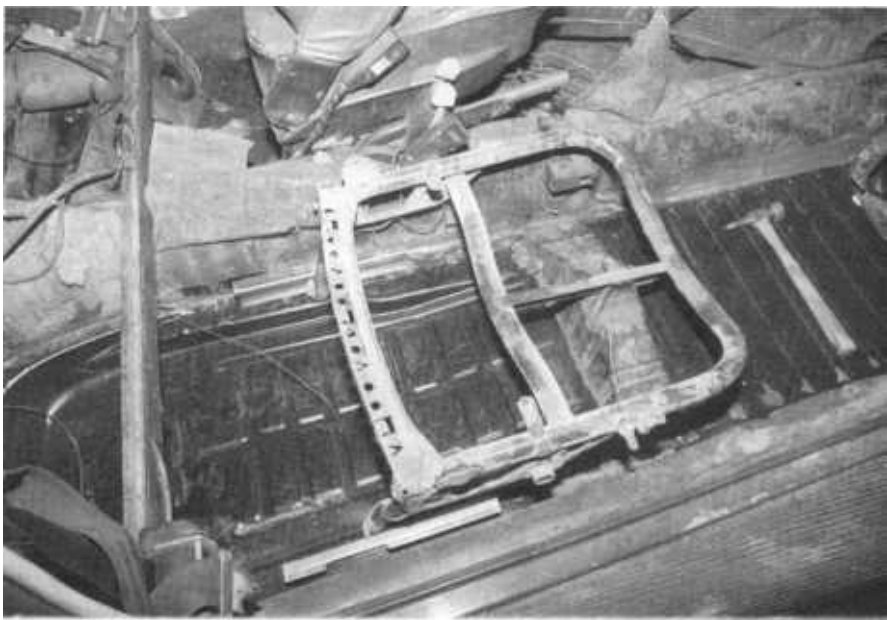
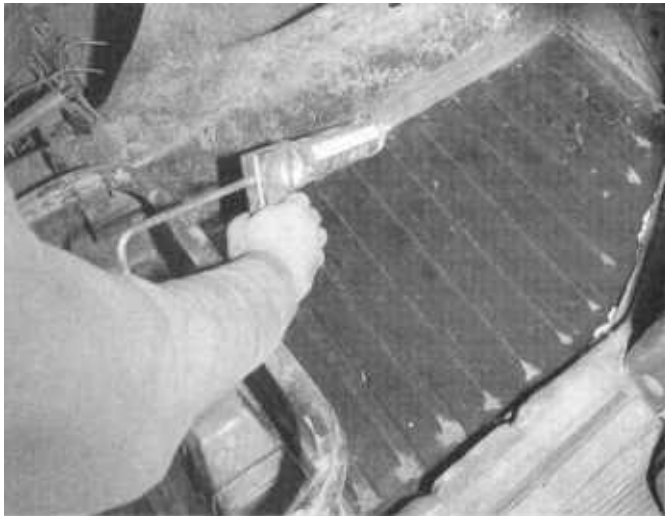
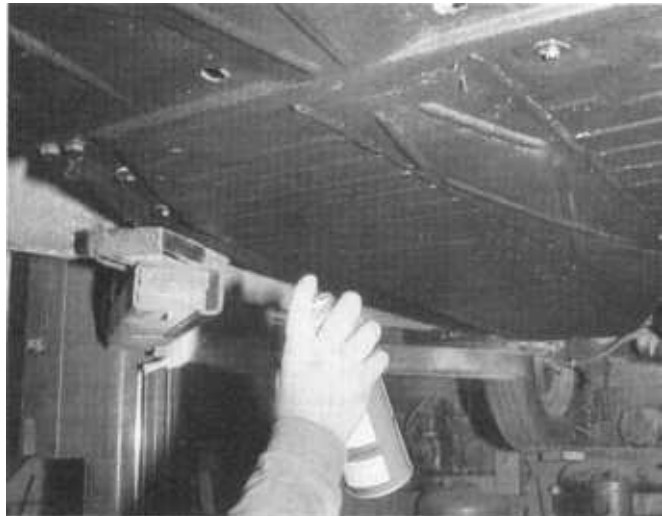
RIGHT, using seat frame as a jig, position side seat rails and weld in place to tunnel and heater channel if they need to be replaced. **BELOW**, body seam sealer is used along welded edge to prevent moisture entry. Prime to prevent rust.

ABOVE RIGHT, after seam sealing, spray the underside with undercoating. **RIGHT**, the finished product looks as good as new!

sealer along the inside seam of the floor section to keep moisture out of the car. Prime and paint the inside of the panel and all bare metal surfaces inside the car. Seam seal the front, back and tunnel side of the panel from the bottom, then coat the entire underside with quality undercoating material. Reinstall the interior and you are in business.
