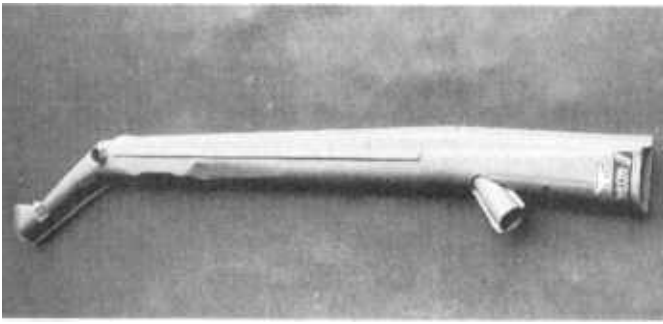
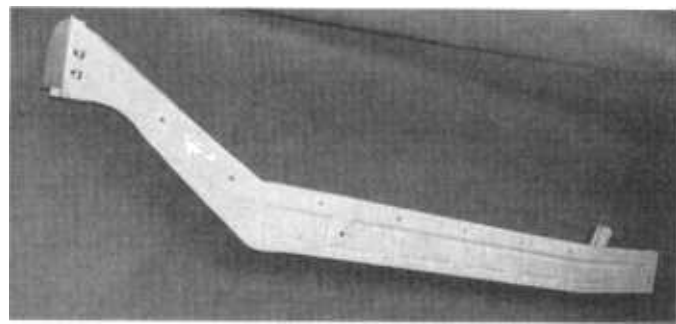
ABOVE LEFT, the replacement heater channel incorporates the upper rocker panel, the front dog-leg extending to the front firewall and the rear connecting pipe. **ABOVE**, this bottom view shows the fastening panel, or bottom plate. Once installed, this part of the heater channel cannot be seen. **BELOW LEFT**, remove the interior before starting to avoid damage. **BELOW RIGHT**, with the running board off (there wasn't anything holding it) you get a good look at an advanced case of heater channel rust.

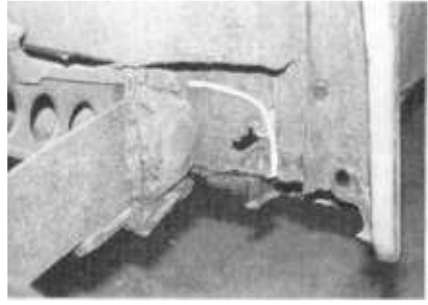
ABOVE LEFT, you can see the backside of the heater channel. **ABOVE RIGHT**, rocks and road debris chip the coating off the wheelwell and it doesn't take long before the bare metal rusts through at the seam between the heater channel and the fenderwell.

As we've mentioned in past rustoration installments, the front of the heater channel extends into the front fender well. This is where rust usually starts. Rocks and debris thrown off the front tires chips the inner fender well, exposing bare metal. A rust

hole then materializes and allows moisture to enter the heater channel area. From here, the water can travel all the way down the channel to the rear seat area and it isn't long before rust has destroyed this vital component. Prevention is the key, if you see any

corrosion in the fender wells, get it taken care of immediately. An inexpensive repair will turn into a major job if not corrected in short order.

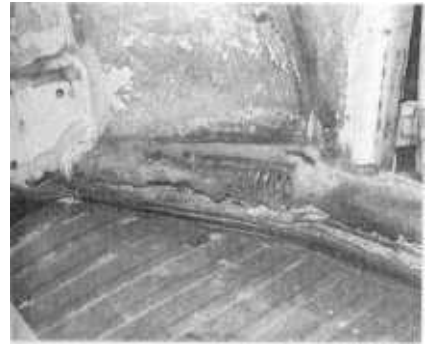
ABOVE LEFT, it is easy to see why there was no front seat heat in this car — there are holes everywhere. **CENTER**, in order for a VW heater to work, the entire system must be in perfect condition. This car has rust holes all along the heater tube. **ABOVE RIGHT**, inside the car, under the back seat, you will find this "Y" connector that diverts hot air to both sides of the car. On all '67 and earlier cars this connector is spot welded to the heater channel and must be cut with a cut-off wheel for removal.
