A professional floor pan repair isn't cheap, but it's the only way to properly correct the problem and hang on to your classic VW. Typical repairs of this type at VW Restorations and Customs run in the \$600 to \$700 dollar range per side. Some models are more, but that is a good average. As you'll see, considering the amount of work involved, this price is quite reasonable.

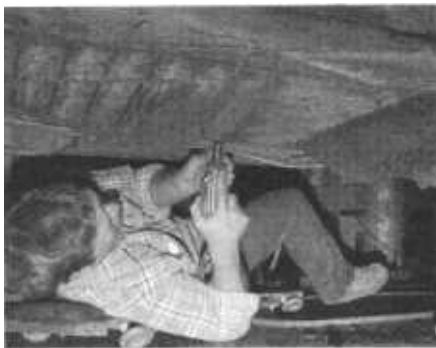
ABOVE LEFT, the first step of our repair required removing the nine body bolts along the outer edge of the floor pan that secure the floor to the body. **RIGHT**, if you are working on the right side of the car, it is wise to carefully relocate the gas tank evaporator hose. Welding, grinding and gasoline fumes are not a good combination.

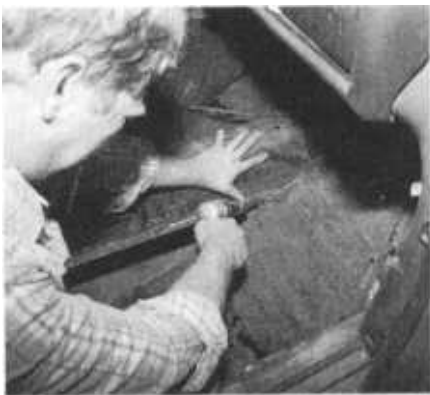
ABOVE, after removing the seats and carpeting, the interior floor pan will be exposed. Pry the outer edge of the pan down from the heater channel, taking care not to damage the pan gasket. Then use an air chisel to break the welds along the tunnel, and front and rear of the floor.

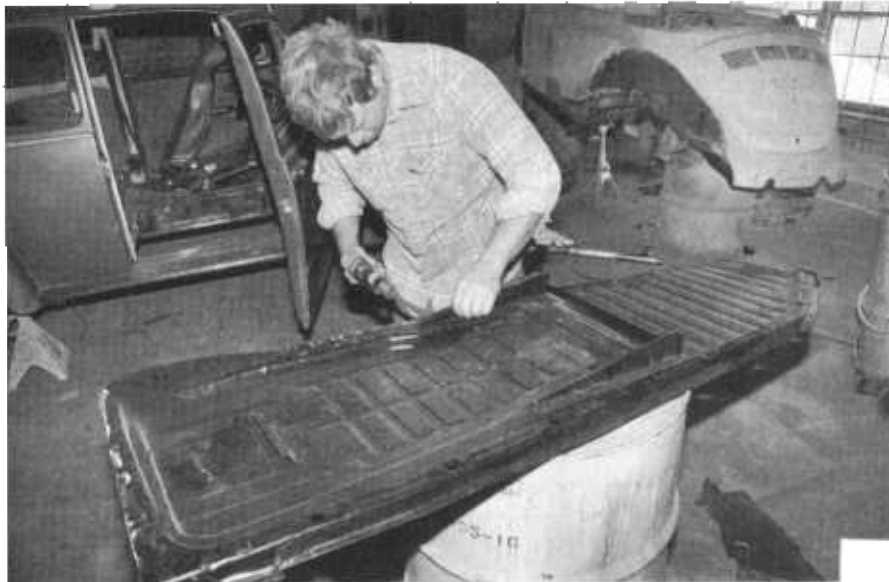
TOP, if using the later seats, remove the rails from the new pan with an air chisel. **RIGHT**, now carefully remove the seat pedestal from the old floor. **ABOVE LEFT**, check pedestal fit by placing on the new pan, and trim as necessary to fit — don't weld in place until the pan is in the car. **RIGHT**, check the new panel for fit, it may be necessary to trim and notch the front edge to clear a factory weld.
